KuDos Mechanical Co.,Ltd.

HYNC – Blade Property of Newton’s 3rd Law forces

EXPLAIN OF NEWTON'S THIRD LAW OF ACTION & REACTION FORCES

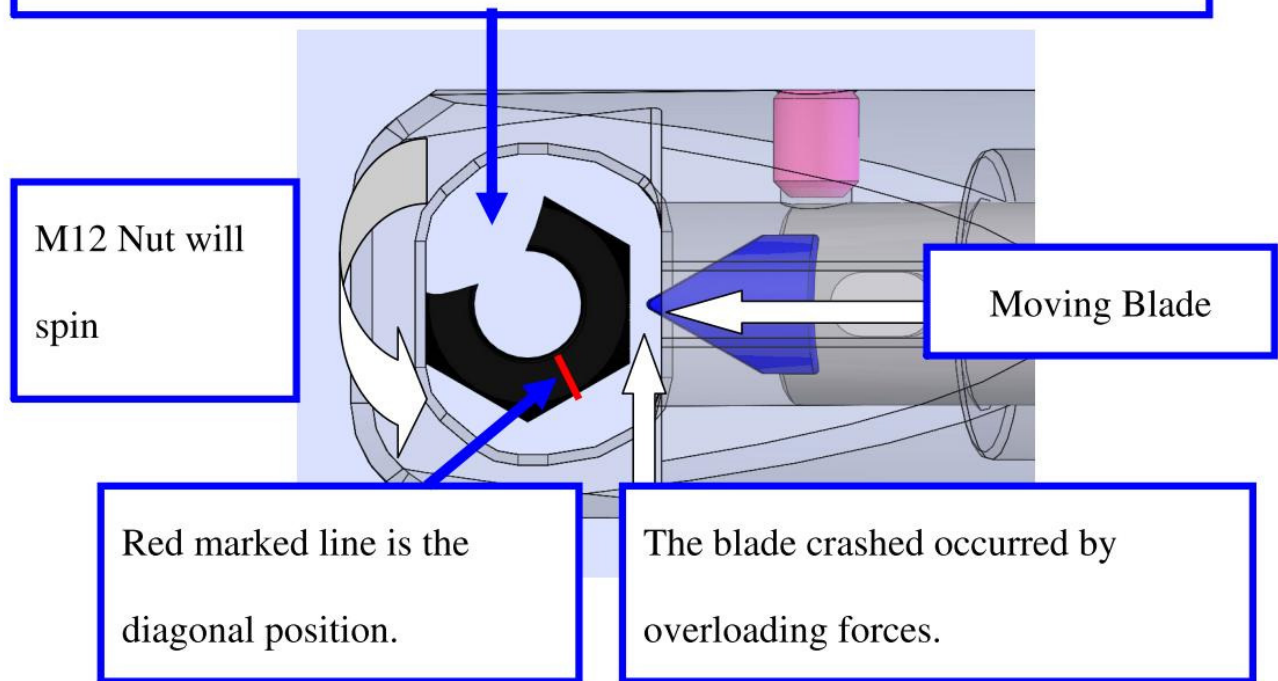
If not in proper position as image, the nut won't separate.

If the nut had gap occurred , the splitter used to be operated by diagonal cut or the blade will be crashed.

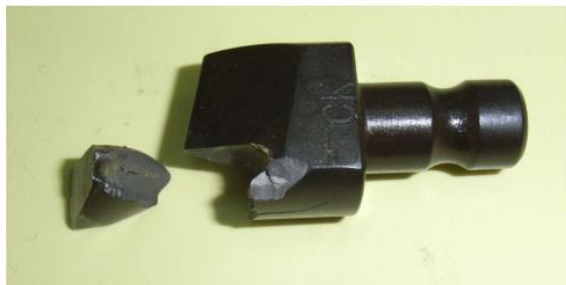
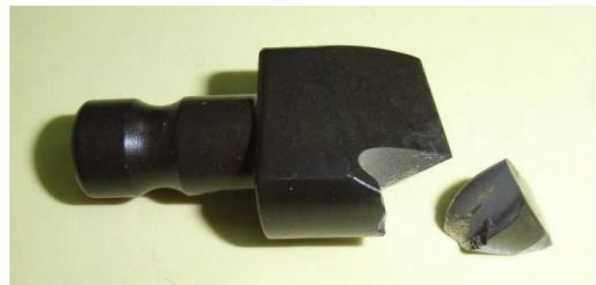
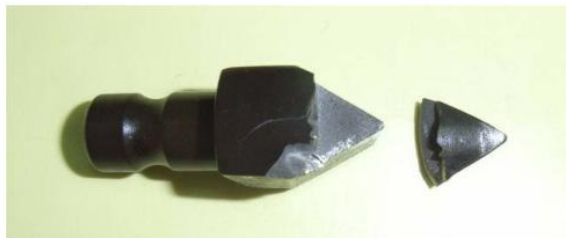
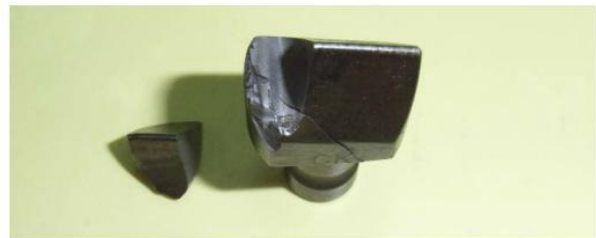
Below is the image of the crashed blades :

Conclusion : The blade crashed occurred by overloading forces, when using should confirm the nut as flat into jaw of splitter and operated by diagonal position.

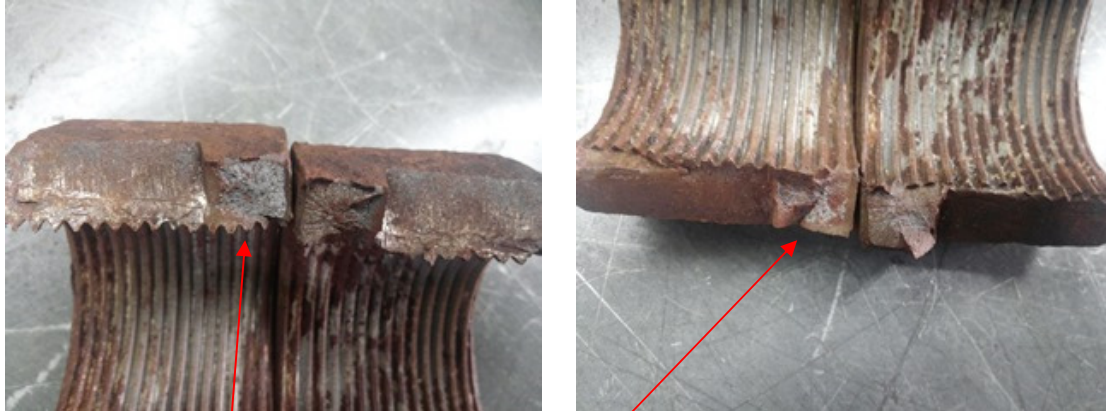
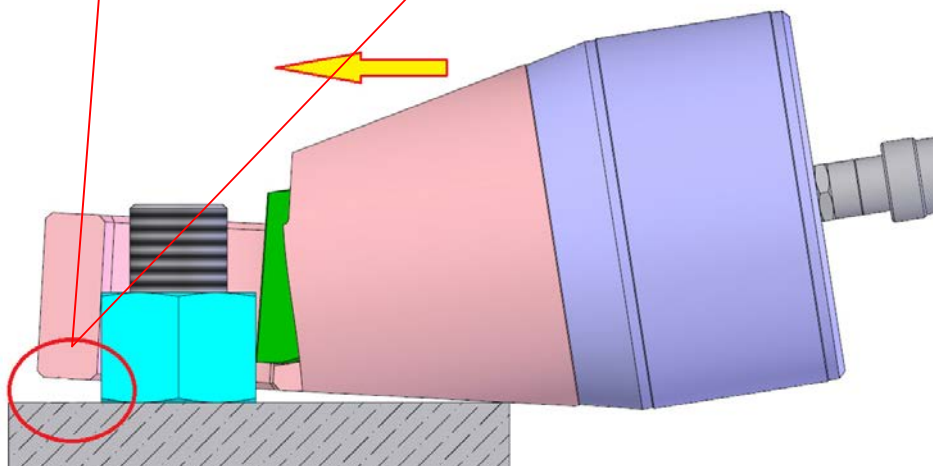
As per the images of nuts found the arrows pointed by not flat splitting nut which will disperse the force against the body of high possibility by tear abrasion.

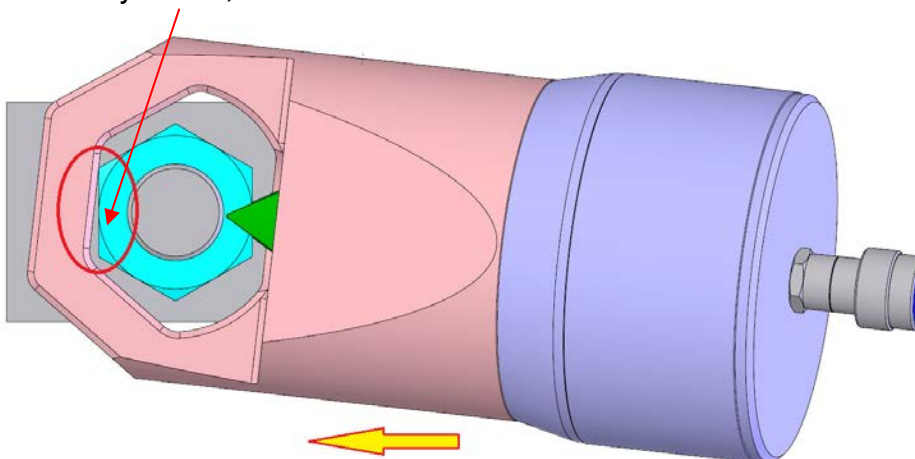
Another failure caused the body crack by misaligns and twisted by splitting as pointed by below,

Please send the cracked piece for our further investigation of the hardness and corrosion issue accordingly.
