KuDos Mechanical Co.,Ltd.

HYNC – Blade Property of Newton’s 3rd Law forces

EXPLAIN OF NEWTON'S THIRD LAW OF ACTION & REACTION FORCES

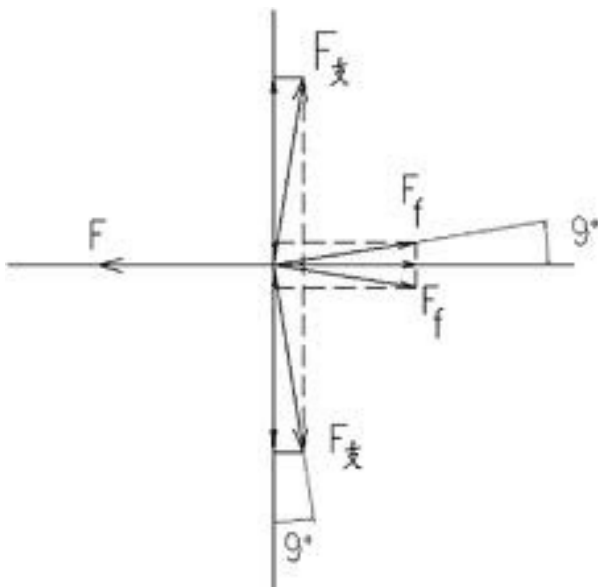
Fig. 1
Newton's Third Law of action

Theory: At meanwhile, operating any splitter to cut nuts will be caused by torque force as this unavoidable force depended on the cutting point against the nut, if the cutting point is not in propose of the blades to be vertical cutting the nut, obviously the nut will be cracked against the torque force and reaction force will feed back to chisel which is the main reason of the blade cracked after cutting by the force feedback at maximum 10,000psi. Please refer to the figures as the Newton’s 3rd law of forces.

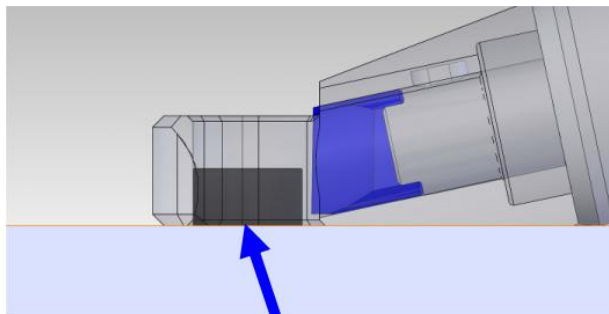
Placed in position

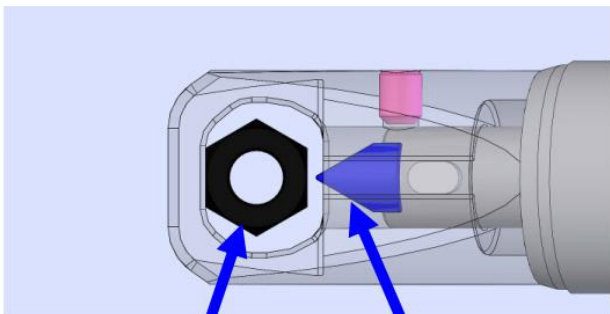
Flat with the Nut

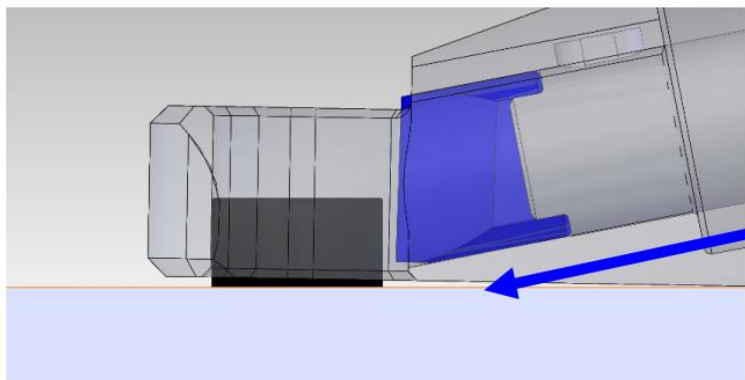
If not in proper position as image, the nut won't separate.

If the nut had gap occurred , the splitter used to be operated by diagonal cut or the blade will be crashed.

Conclusion : The blade crashed occurred by overloading forces, when using should confirm the nut as flat into jaw of splitter and operated by diagonal position.
